GROUNDING SOLUTIONS FOR OKTAVA MK-012 MICROPHONES

BY EMANUELE COSTANTINI

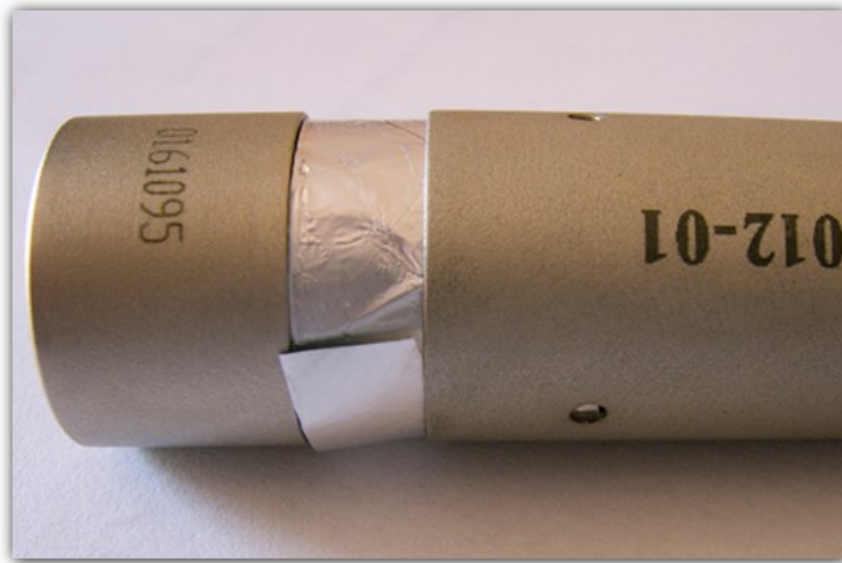
Picture 06

Another manufacturing flaw occurs with the area between the cover (the ground of the capsule) and the connector. The cover doesn't rest up perfectly against the connector and gets separated even more by the internal screws that tend to push it away once screwed in completely. This keeps the capsule's ground disconnected from the circuit ground.

It would be advisable to use screws with a head on the outside (as opposed to the headless internal screws currently used), as they would force contact by pushing the cover onto the connector, thus guaranteeing a strong connection. I've been having some difficulty finding these screws and was hoping to find them in a watch repair shop or something similar. For now, I use a ring of aluminium foil that, placed in the affected area, improves contact once the cover is in place, as shown in Picture 06.
